耐火被覆吹付けロボットの高機能化

Upgrading Fireproof Coating Spraying Robots

Kohei Ueda Hajime Sakagami
Hirofumi Segawa Yuichi Ikeda

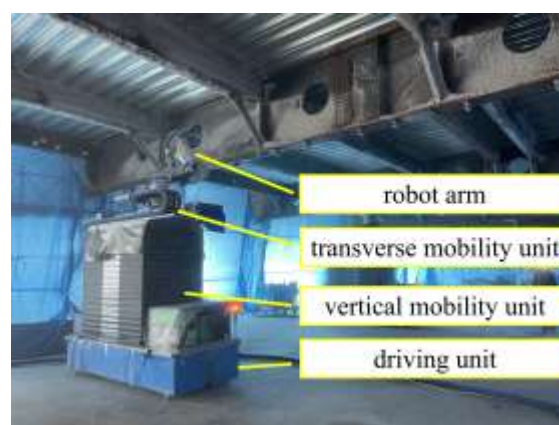
Fig. 1 Fireproof coating spraying robot

Fireproof coating spraying, particularly during summer, suffers from a significant shortage of skilled workers because of harsh working conditions. To address this issue, construction companies have actively developed technologies aimed at reducing the labor requirements in fireproof coating operations¹⁾. At Obayashi Corporation, we developed a fireproof coating spraying robot (hereafter referred to as “the robot,” Fig. 1) to automate the spraying process in semi-dry sprayed rock wool fireproofing applications²⁾.

The robot was equipped with autonomous mobility functions. By registering the movement path and target beams in advance, the robot can automatically perform a series of operations, such as moving to the target beam, spraying, and then moving to the next beam. Based on previous field applications³⁾, productivity was found to improve by having one operator manage multiple robots rather than a single worker performing manual fireproofing work.

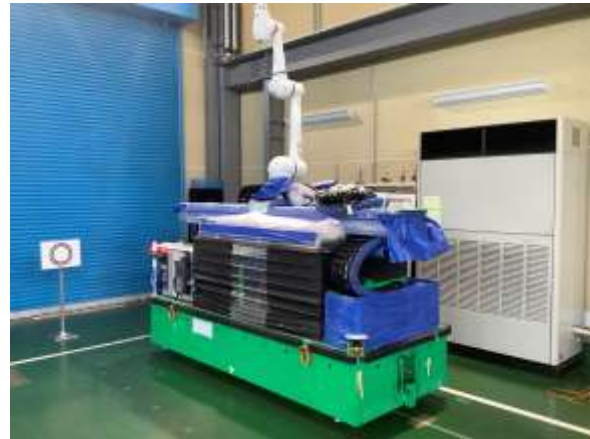
Fig. 5 Indoor environment during development

The robot failed to automatically recognize the targets primarily due to the significant difference between the indoor development (Fig. 5) and the actual construction site

environment (Fig. 6). For example, while lighting in the indoor development environment was constant, the brightness at the construction site varied greatly depending on weather conditions (e.g., sunny or cloudy) and the time of day.

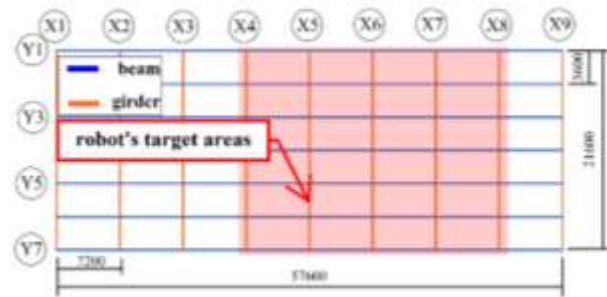
Fig. 8 Robot target areas

3.2.1 Robot's Target Areas The robot was assigned even-numbered floors from 8th to 26th. These floors required either 3 h or 2 h fire resistance. Fig. 8 shows the target areas of the robot on each floor. The spray targets included both small and large beams within the designated office area. The target area of the robot per floor was approximately 400 m².

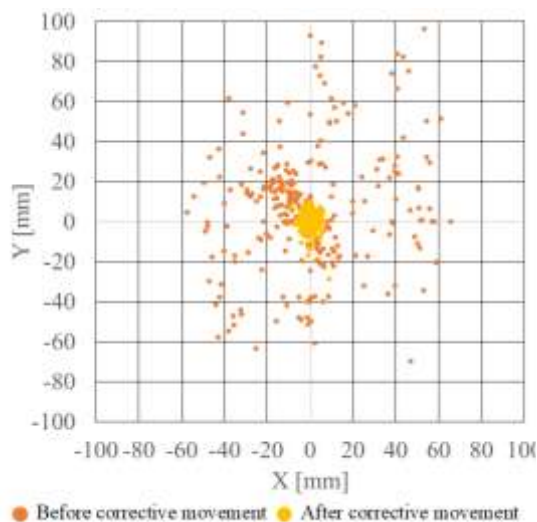
Fig. 12 Errors before and after corrective movement

The positioning errors before and after corrective movement are shown in Fig. 12 and Table 2. In Fig. 12, there is a significant reduction in the spread after corrective movement. Comparing the errors in the x- and y-directions, the standard deviation in the x-direction is larger. This is attributed to the orientation of the mecanum wheels installed on the driving unit. These wheels behave differently when moving in the travel direction (y-axis) versus the transverse direction (x-axis), particularly under site conditions affected by dust and rainwater, which may cause slippage and prevent accurate positioning.

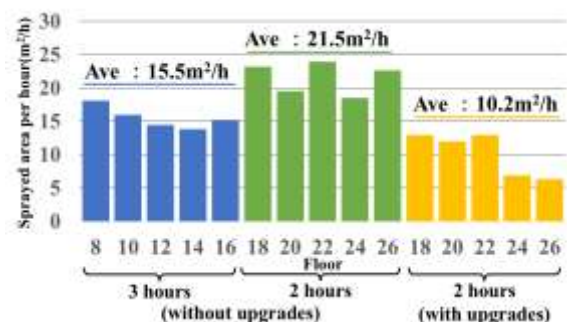
Fig. 15 Productivity summary of spraying per floor

Fig. 15 summarizes the productivity of the spraying operations per floor, comparing cases with and without functional upgrades. For 3 h fire resistance floors without upgrades, the robot achieved an average productivity of approximately 15.5 m²/h, which is a 35% improvement over manual fireproofing. For 2 h fire resistance floors, an average productivity of approximately 21.5 m²/h was obtained, representing a 50% improvement. The thinner coating required for the 2 h resistance reduced the spraying time, contributing to higher productivity.

In contrast, with functional upgrades enabled, the productivity of 2 h fire-resistance floors averaged only 10.2 m²/h, approximately 70% of the manual fireproofing productivity attributed to the additional time spent on target and beam measurements.

Despite lower productivity, the autonomous operation of the robot reduced the workload of the operators, enabling one operator to manage multiple robots. This approach is expected to increase overall productivity per operator beyond that of manual workers. For example, operating two robots at 70% productivity would result in a combined productivity that is approximately 1.4 times higher than that of a single manual worker. Additionally, the beam-recognition function is expected to improve spray quality.
